CALIFORNIA REGIONAL WATER QUALITY CONTROL BOARD - SAN DIEGO REGION

FACILITY INSPECTION DATA ENTRY FORM

Inspection Date: December 22, 2008

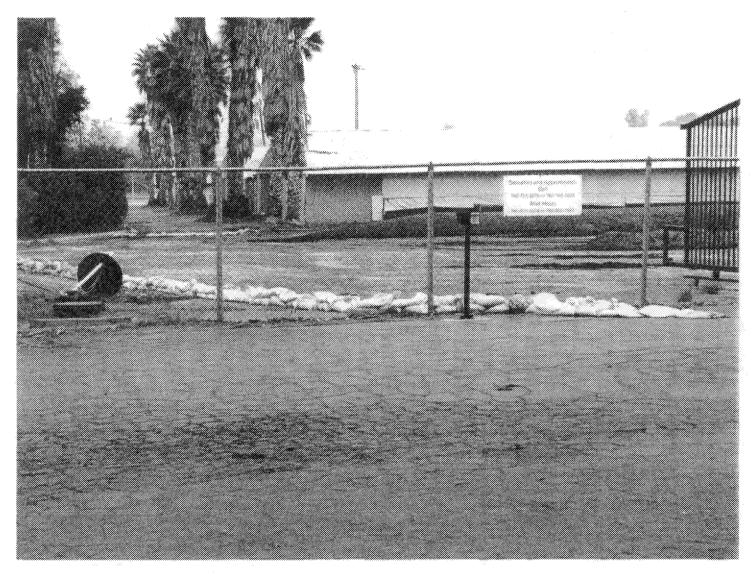
Photo shows some of the temporary best management practices installed by the owners to prevent the discharge of waste water from the site. This inspection occurred on a rainy day, and staff did not observe any runoff or discharges of waste water from the site.

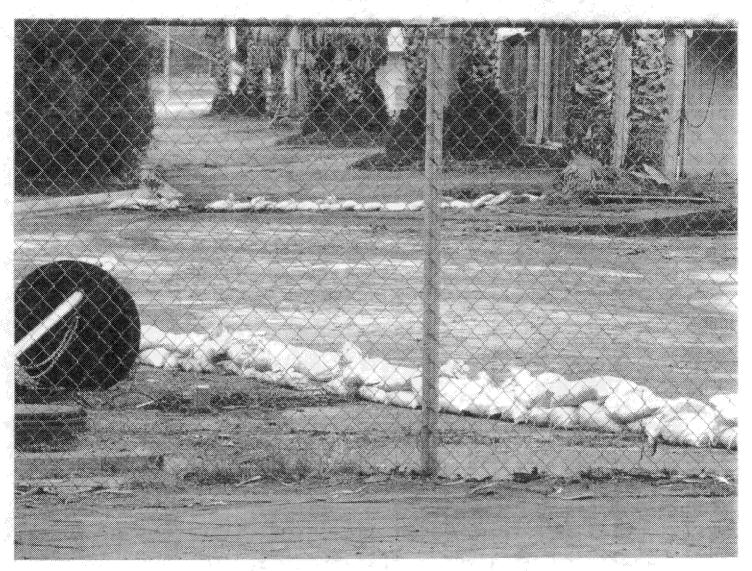
Inspection Date: December 22, 2008

This is the same photo shown above at a closer range. The owners installed sand bags as temporary controls for runoff. According to the owners, these temporary measures will remain in place until the permanent best management practices or management measures can be installed.

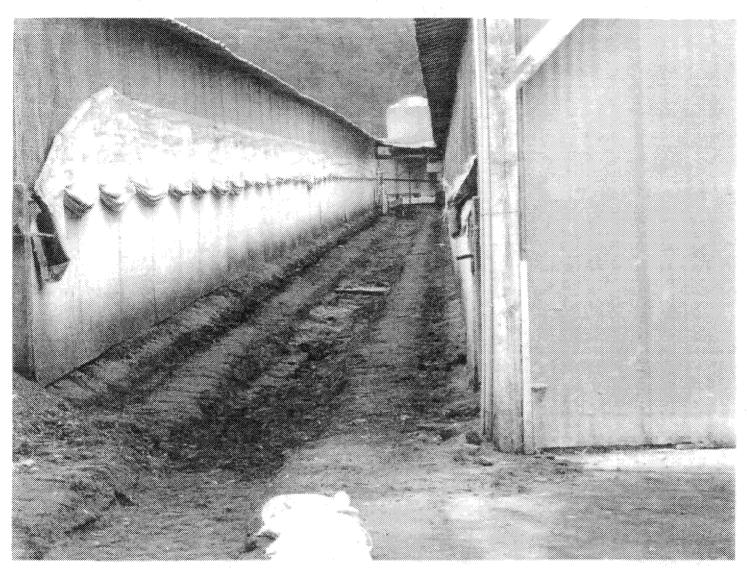
Inspection Date: December 22, 2008

This photos depicts as earthen trench constructed by the owners to divert storm water and/or waste water back onto the site, and to prevent the illicit discharge of these waters from the site. Staff recommended the owners line the trench to help prevent sediment build-up, and to make this a more permanent management measure.

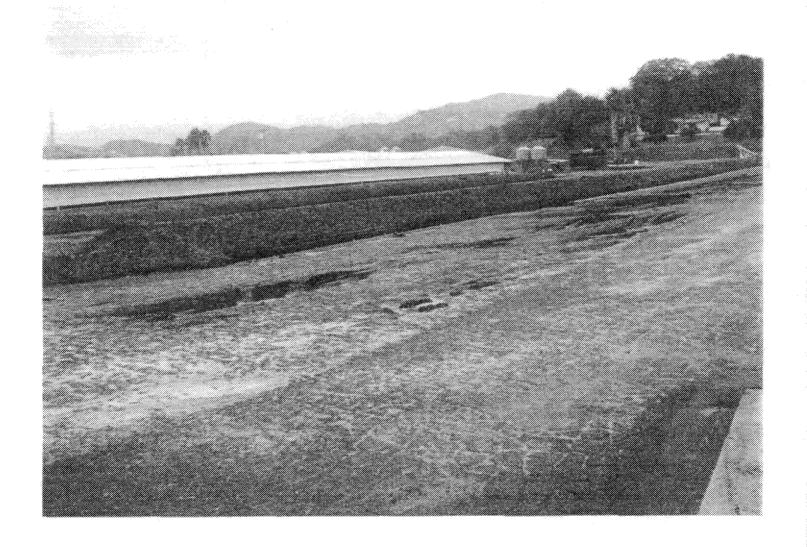
Inspection Date: December 22, 2008

This photo depicts one of the composting areas. The photo shows that the area is lined with asphalt, preventing infiltration of nutrients into groundwater in this area. Permanent best management practices have not yet been installed in this area due to issues with the machinery used in composting. More permanent measures will be installed once a decision is made regarding the number of detention ponds appropriate for this site.
